Manhole Inspection Summary

Manhole # S25MM1004MH

Insp Date: **11/6/06 9:33 AM**

Location Address: **102 RIDGE WOOD RD**

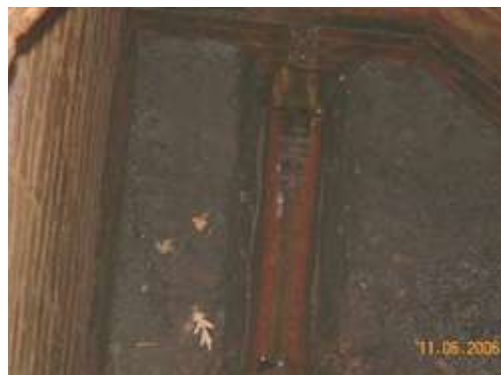
Top View

Adjustment and Barrel infiltration.
Evidence of surcharge - Bench debris.

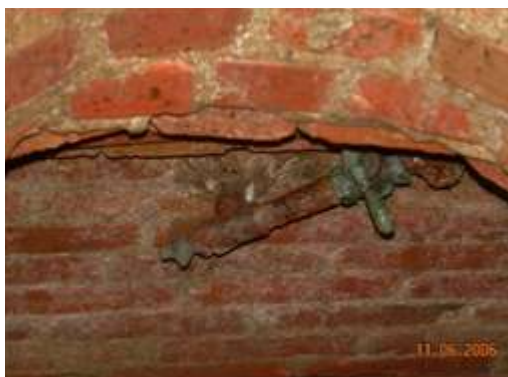
Faucet

Adjustment and Barrel infiltration.

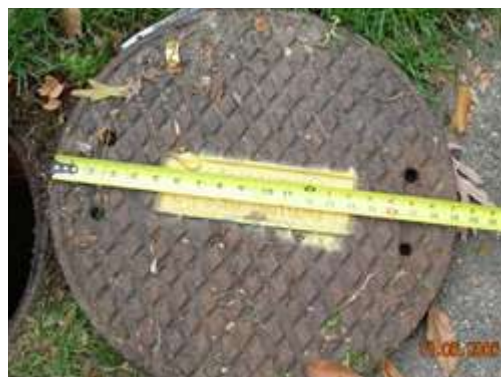
18" LID

18" Lid

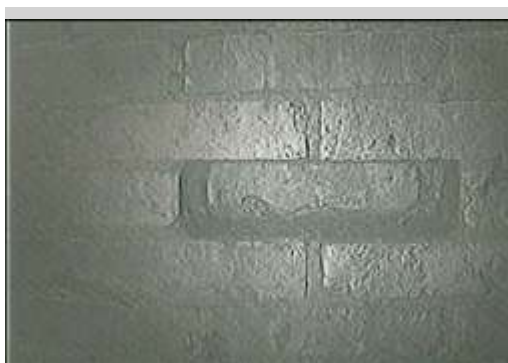
Defect

Recesses brick - may be a step.

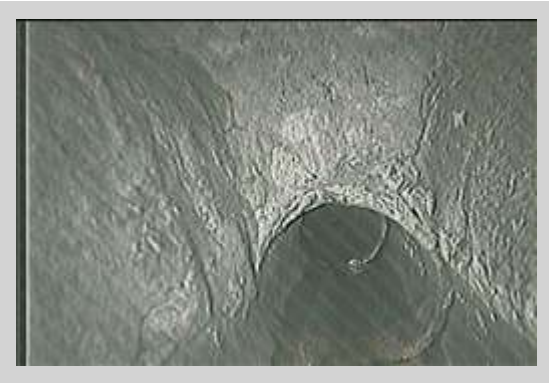
8 in. Circular Gravity Sewer Pipe Out @ 12 O'Clock

Infiltration: **Evidence** Pipe Seal Cond: **Broken**

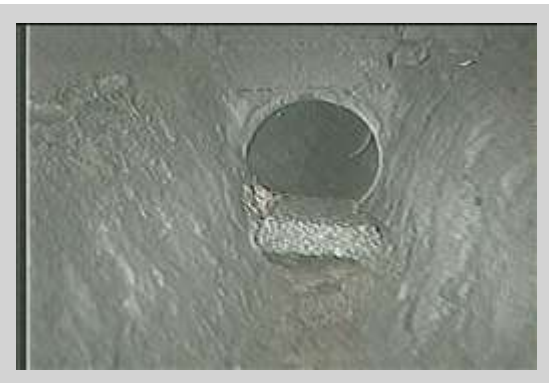
8 in. Circular Gravity Sewer Pipe In @ 6 O'Clock

Deposits: ☐ None ☐ Mud ☐ Sludge ☒ **Debris** ☐ Grease

Silt Depth: **1** (in.) Deposits Extent: **Light**
